FAR OUTSIDE THE NORM:
The San Onofre Nuclear Plant's
Steam Generator Problems
in the
Context of the National Experience with
Replacement Steam Generators

by
Daniel Hirsch
and
Dorah Shuey

September 12, 2012

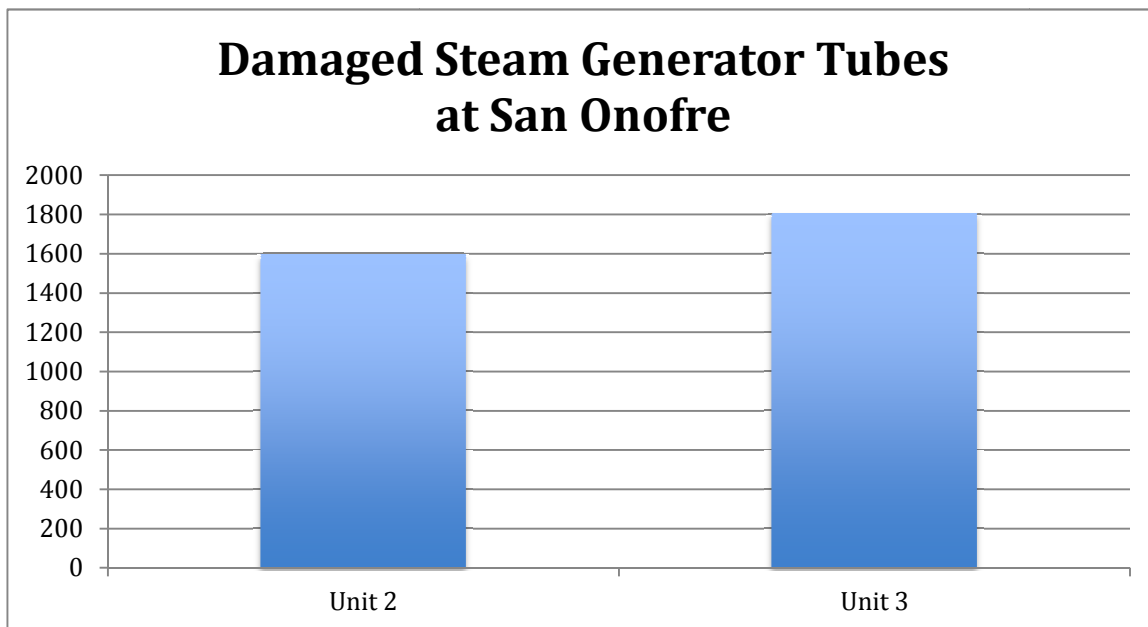
Figure 2

The data tables posted by NRC show similar numbers of damaged tubes in the two units. Unit 2 has 1,595 tubes with wear, Unit 3 has 1,806.

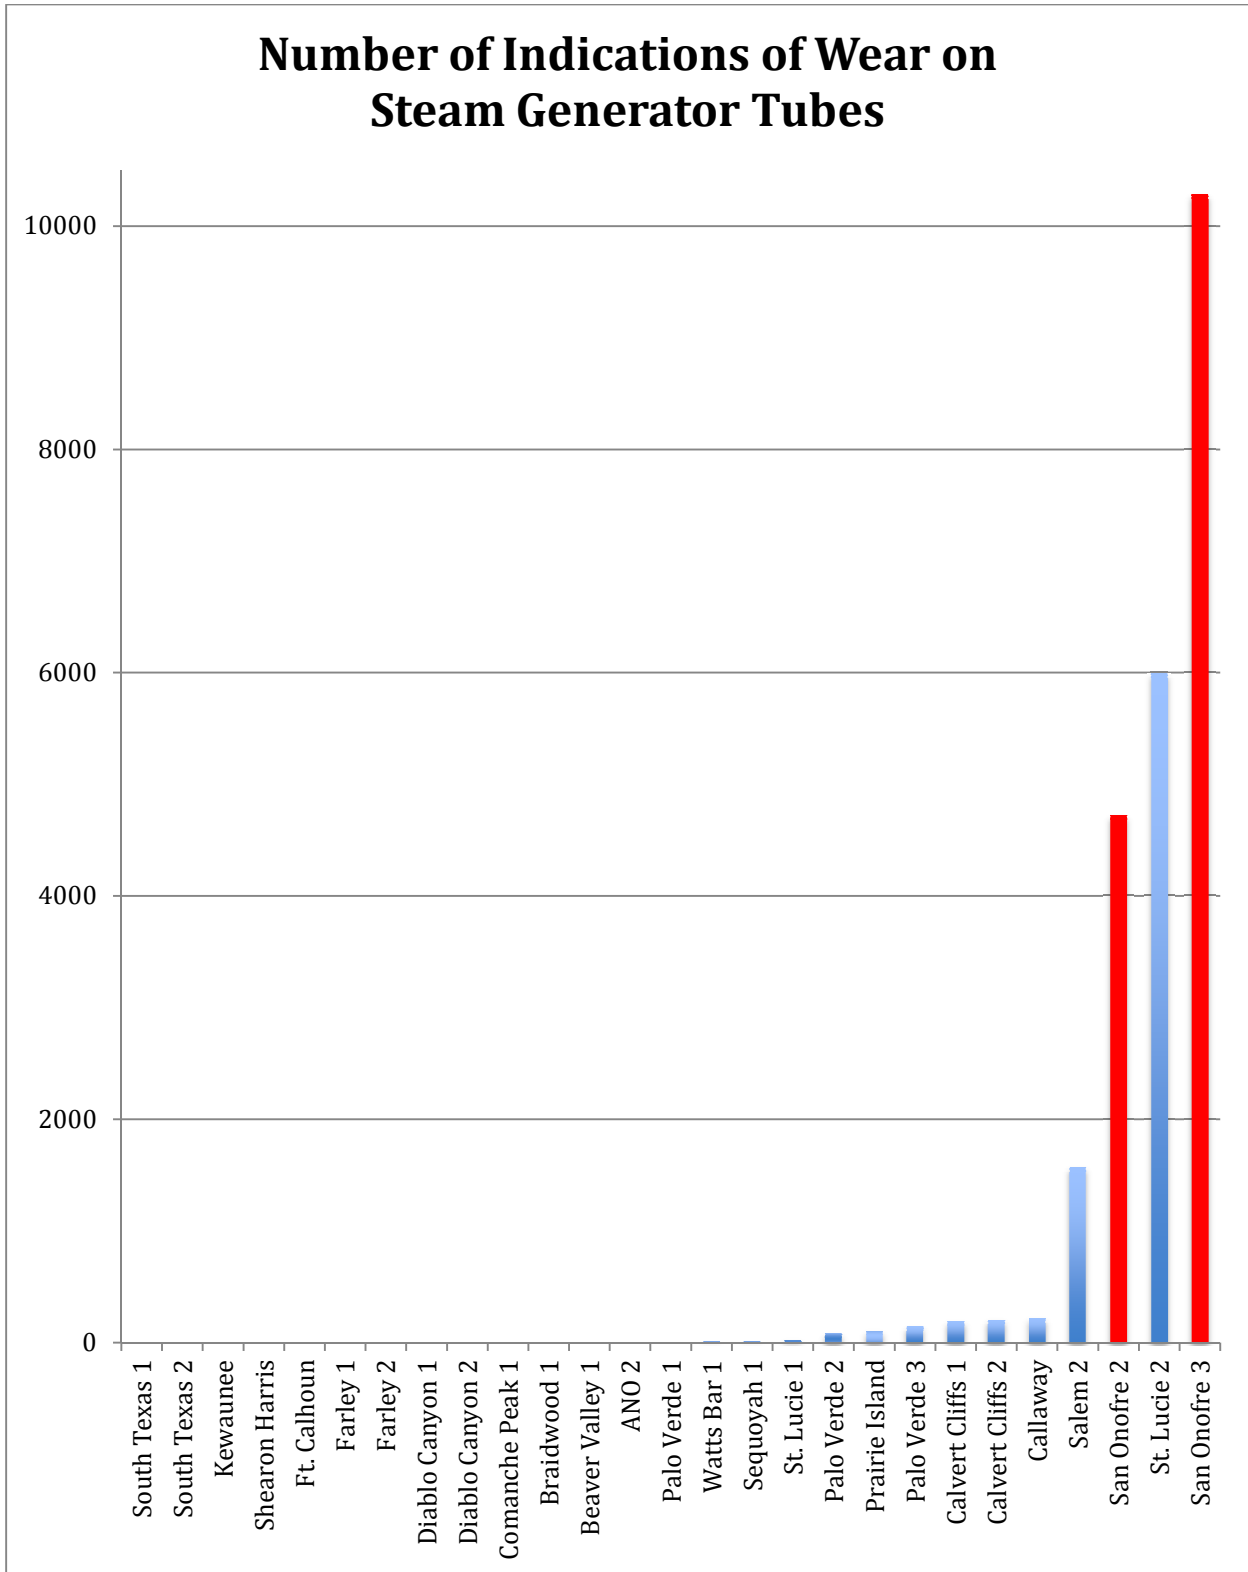
Figure 3

As dramatically shown in Figures 3, 4, and 5 of this report, the San Onofre experience after only two or less years of operation with replacement steam generators lies far outside the bounds of normality when compared to the experience of other nuclear units with such replaced components. Steam generators, and more specifically the tube boundaries, play a critical role in assuring plant safety and the containment of possible radioactive releases. In spite of Edison's attempt to assert a different level of risk between Units 2 and 3, it seems clear that similar design and failure challenges are present in both units and that future operation of either unit has not been technically justified. It is my opinion that measures necessary for the future safe operation of either of these unit have not been adequately put forth at this time, and that operation with or without reduced power of Unit 2 should not be authorized.

- **The median number of steam generator tubes showing wear after one cycle of operation nationally is—FOUR. San Onofre Unit 2 had 1595 damaged tubes, approximately 400 times the median; San Onofre Unit 3 had 1806.**
- **The median number of wear indications on steam generator tubes after one cycle of operation is—FOUR. San Onofre Unit 2 had 4721, greater than a thousand times more. San Onofre Unit 3 had 10,284.**
- **The median number of steam generator tubes that were plugged after one cycle of operation is—ZERO. San Onofre Unit 2 had 510; Unit 3 had 807.^{xxi}**

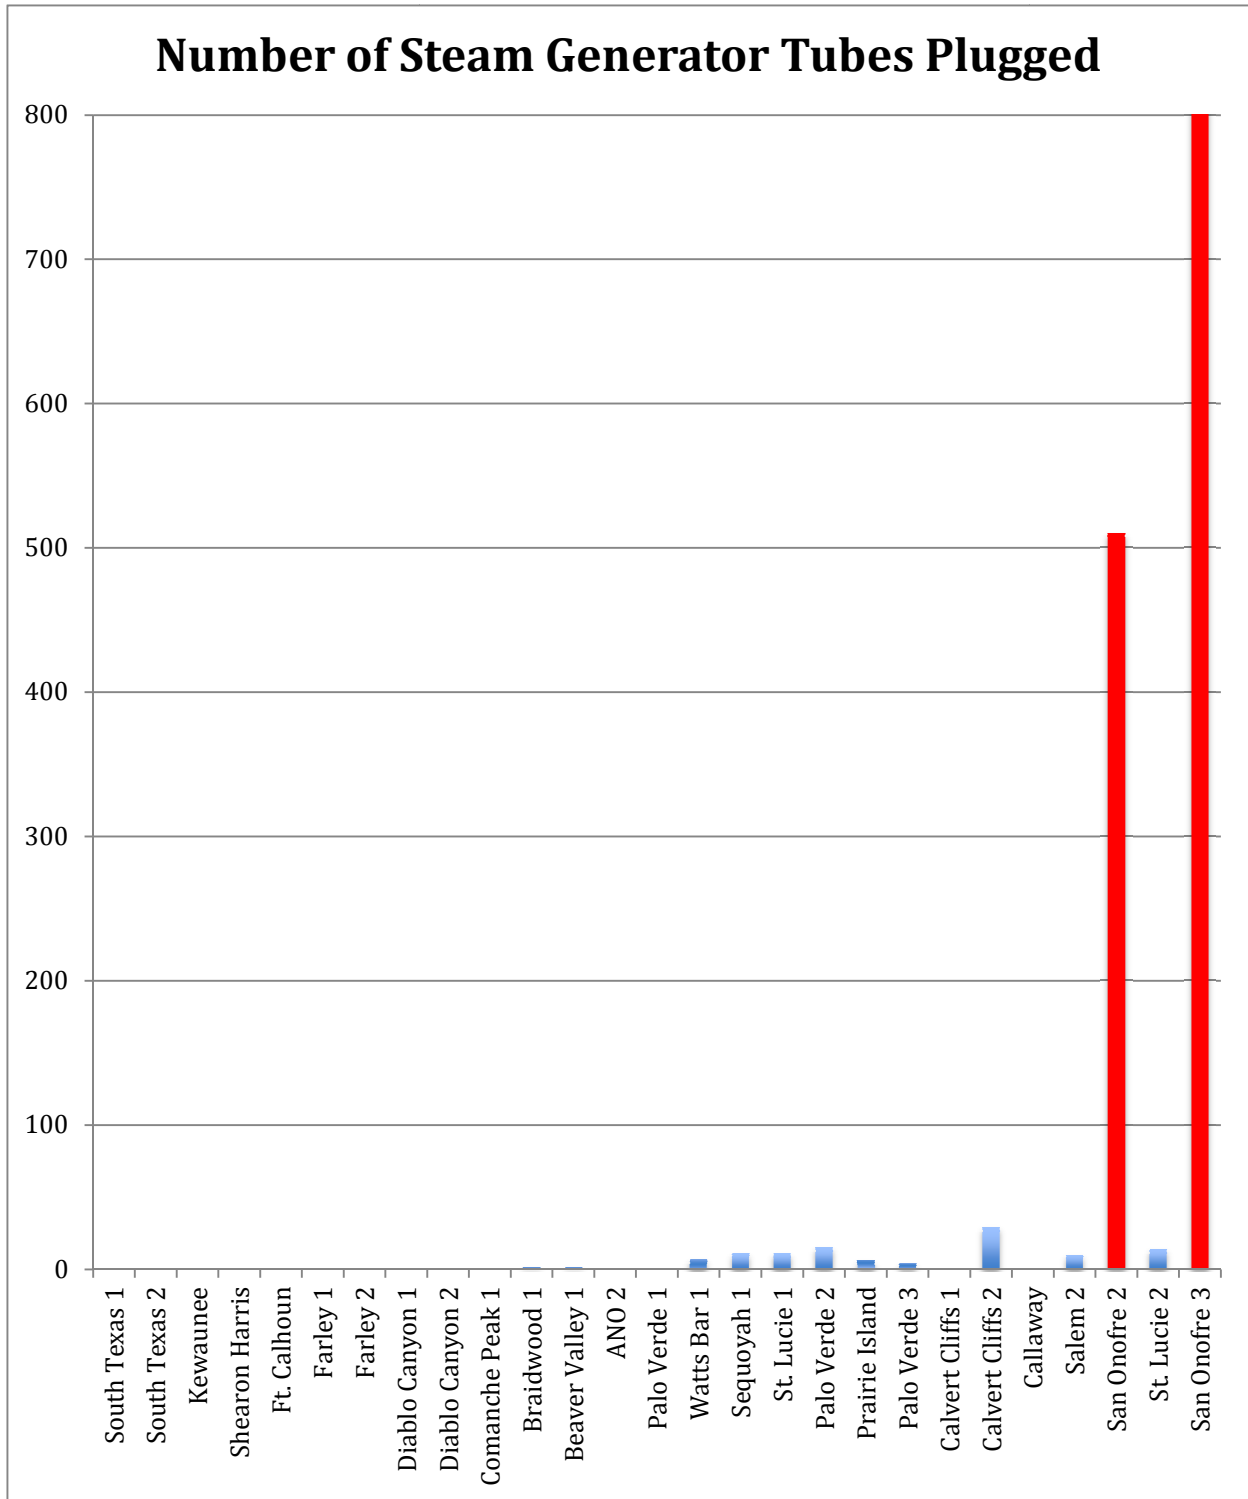
Figure 5

Additionally, as will be seen in Table 3 and Figure 5, the number of steam generator tubes that have had to be plugged in each reactor is in the same approximate range: 510 in Unit 2 and 807 in Unit 3. As this report shows, these numbers are dramatically higher than the national experience. Each San Onofre unit has had to plug many times more tubes than all reactors with new steam generators in the country, over a comparable operational period, combined.
