Accident Investigation Report (AIR)

Project: Coal Mine

Package: SPL Coal Mine

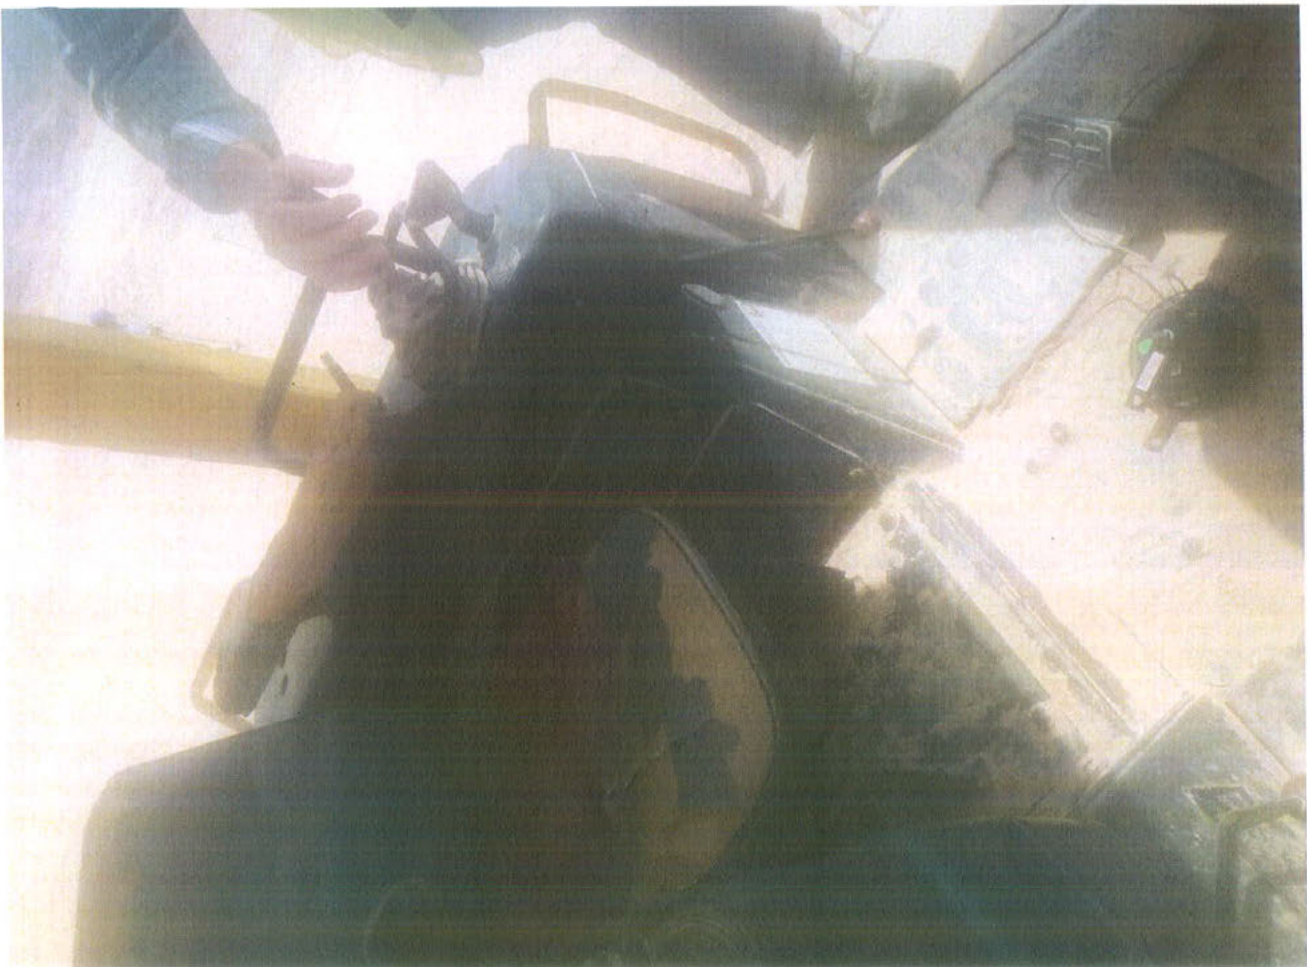
Photo 1. Showing Left Joystick: Joystick controls: (Steering, directional and gear shift levers)

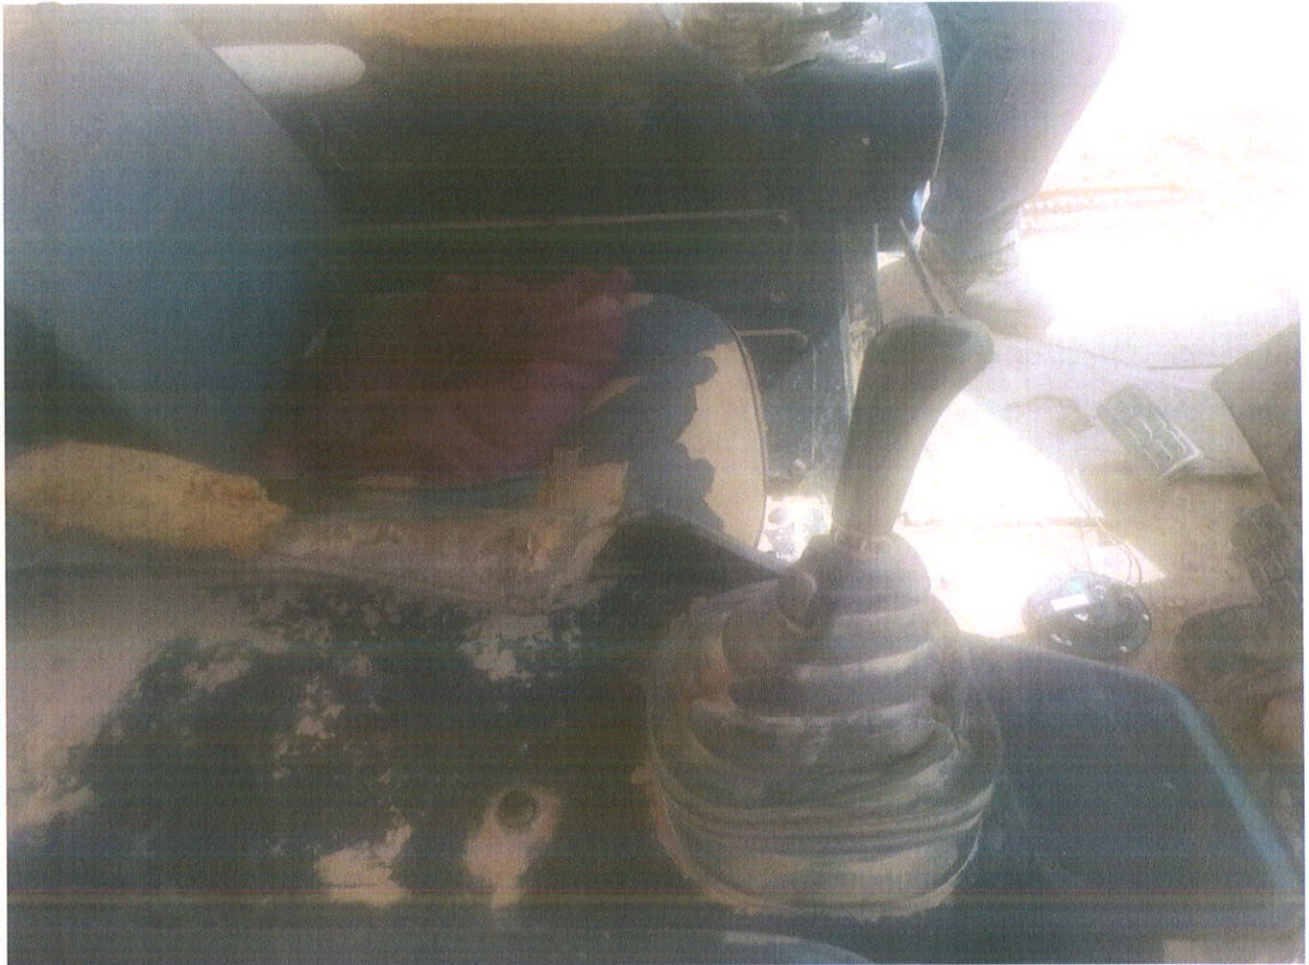
Photo 2. Showing Right side Joy Stick for Blade Control

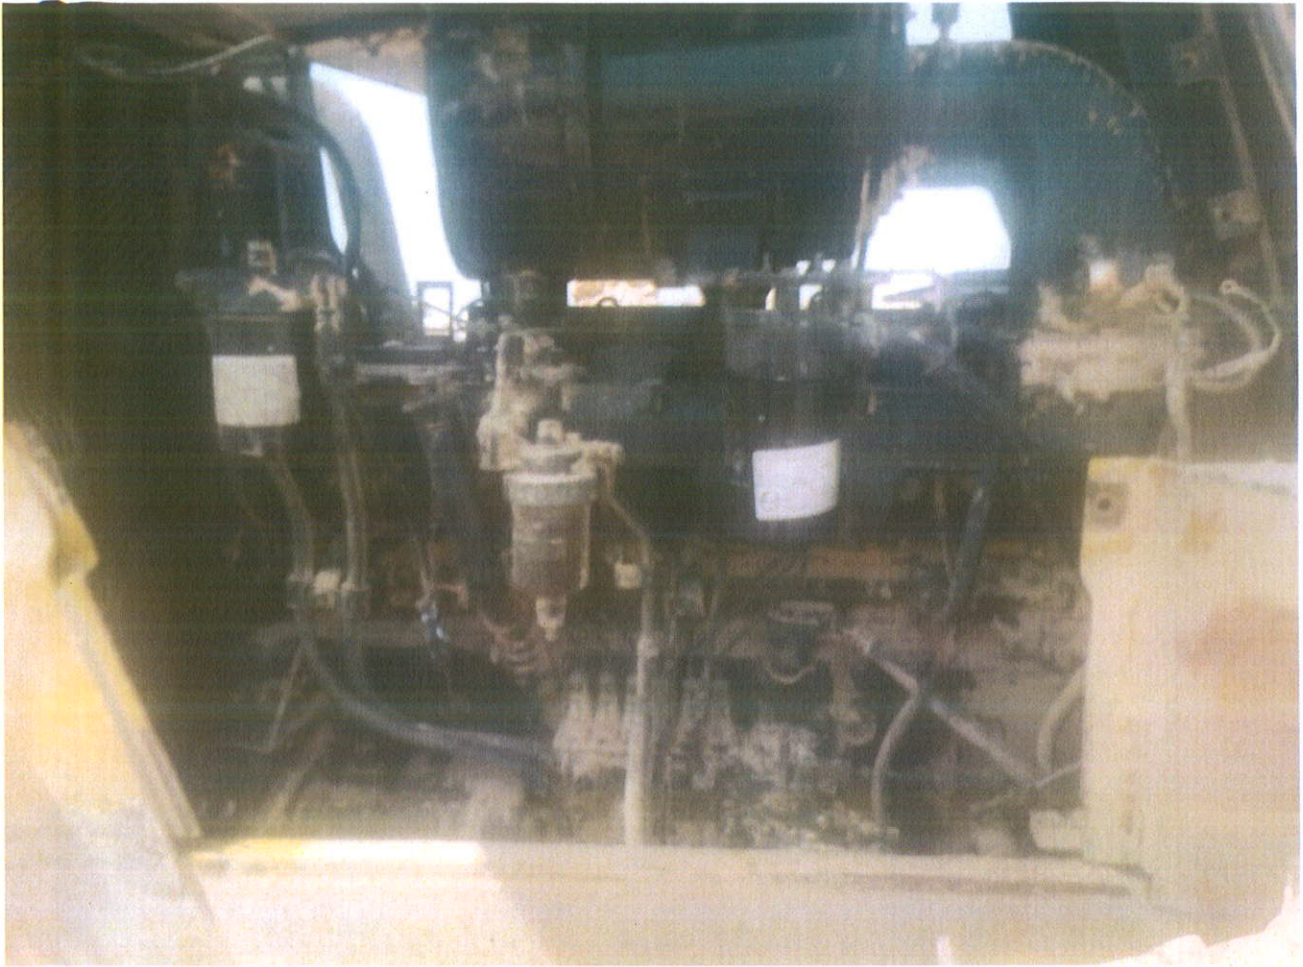
Photo 3. Machine engine covers were open on both sides of machine as part of the changing oil process

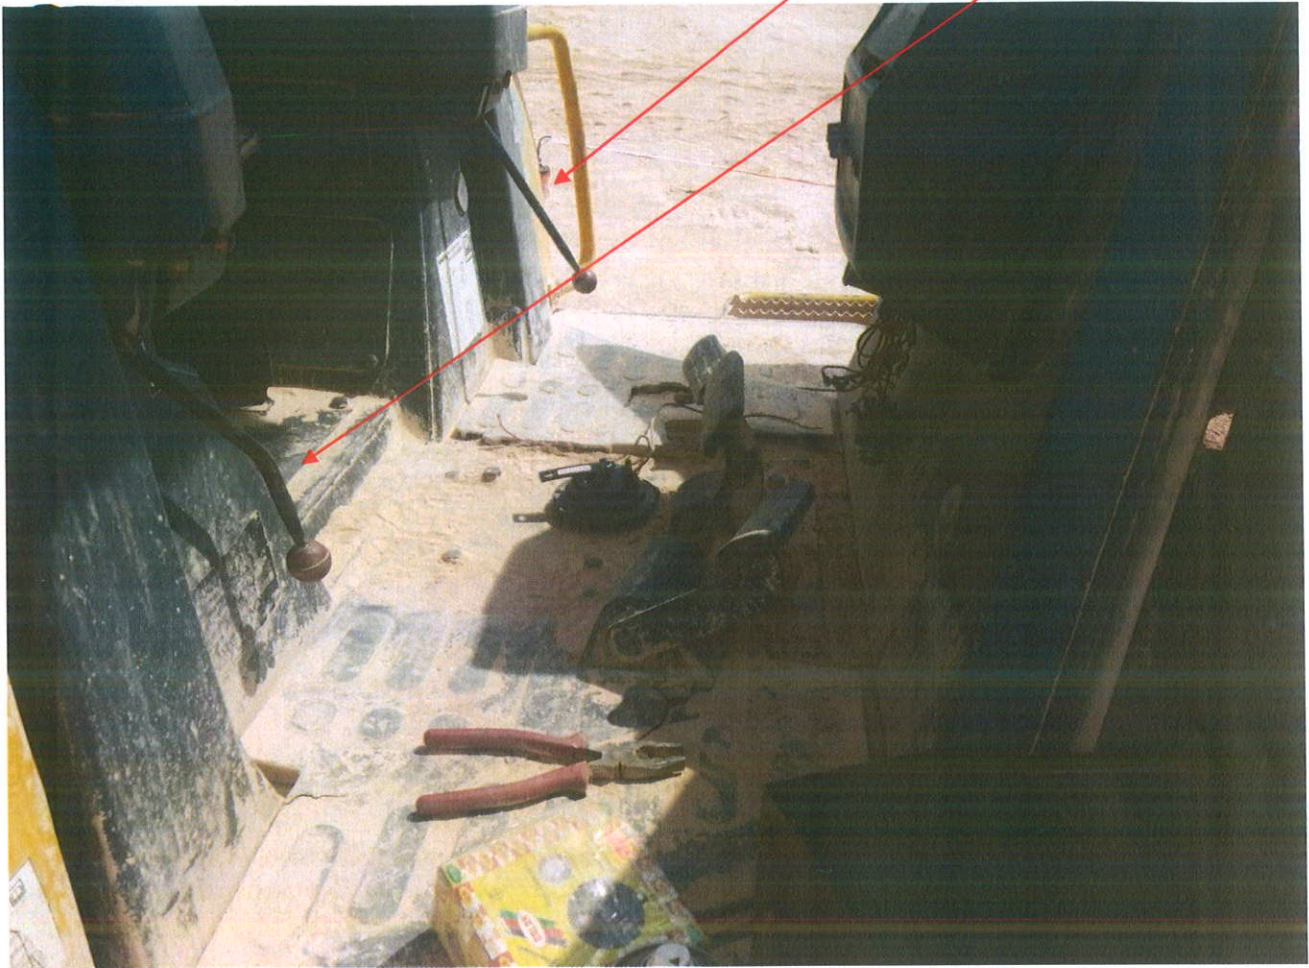
Photo 4 showing replacement Horn and tools used by Electrician, Park Brake and Blade Control Levers in locked position

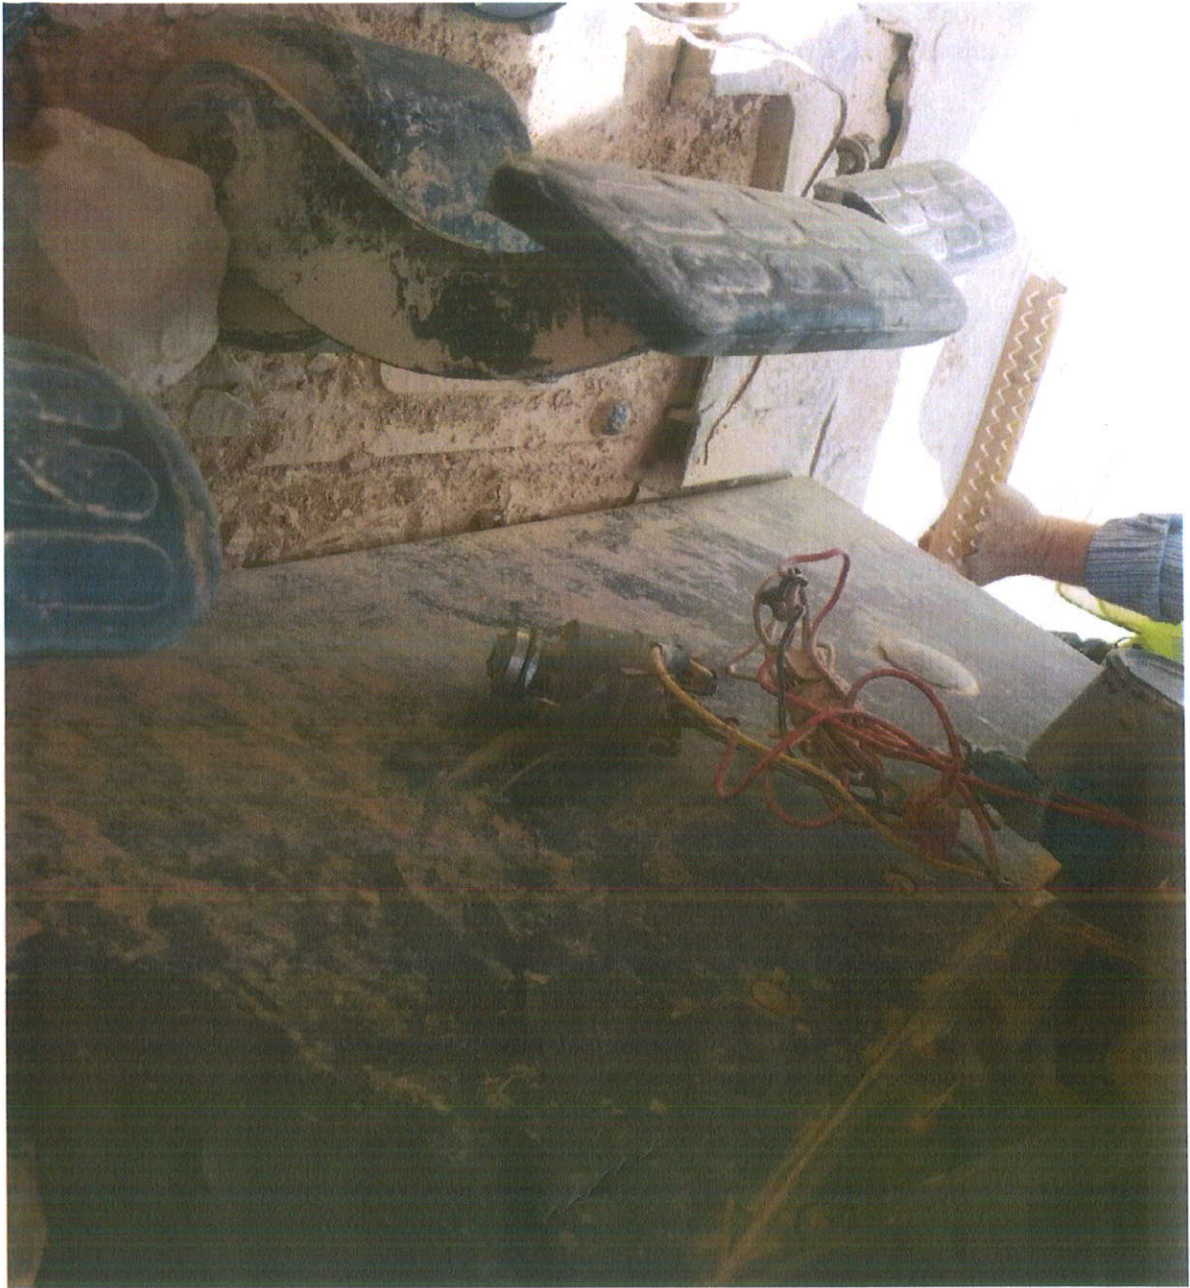
- i. Safety & Parking lever on RH and LH of the seat were found operational.
- ii. Ignition switch was not available on the machine. Crude & non insulated wires were seen hanging dangerously. Accidental grounding can even start/stop the engine & even cause a fire hazard.
- iii. Horn was not working .

The starting switch on the Dozer had been defective from 8 May 2016.

Photo 5 Ignition Switch removed from Dash

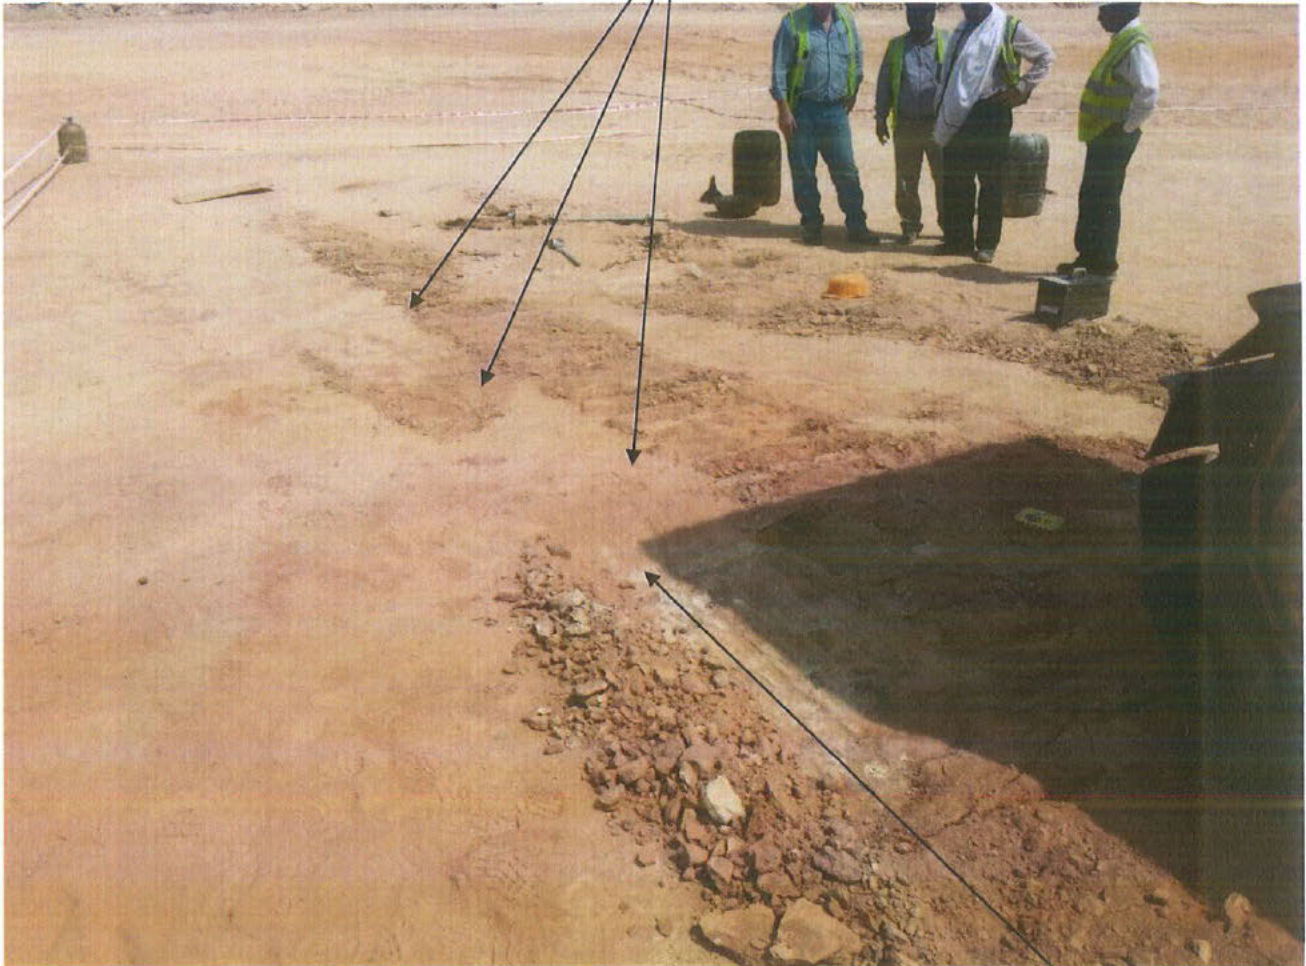
Photo 6. Showing blade marks on right side of machine (note blade marks were not continuous) indicating (b)(6) had raised and lowered the blade

Blade marks increased in depth at this position indicating blade was lowered by (b)(6)

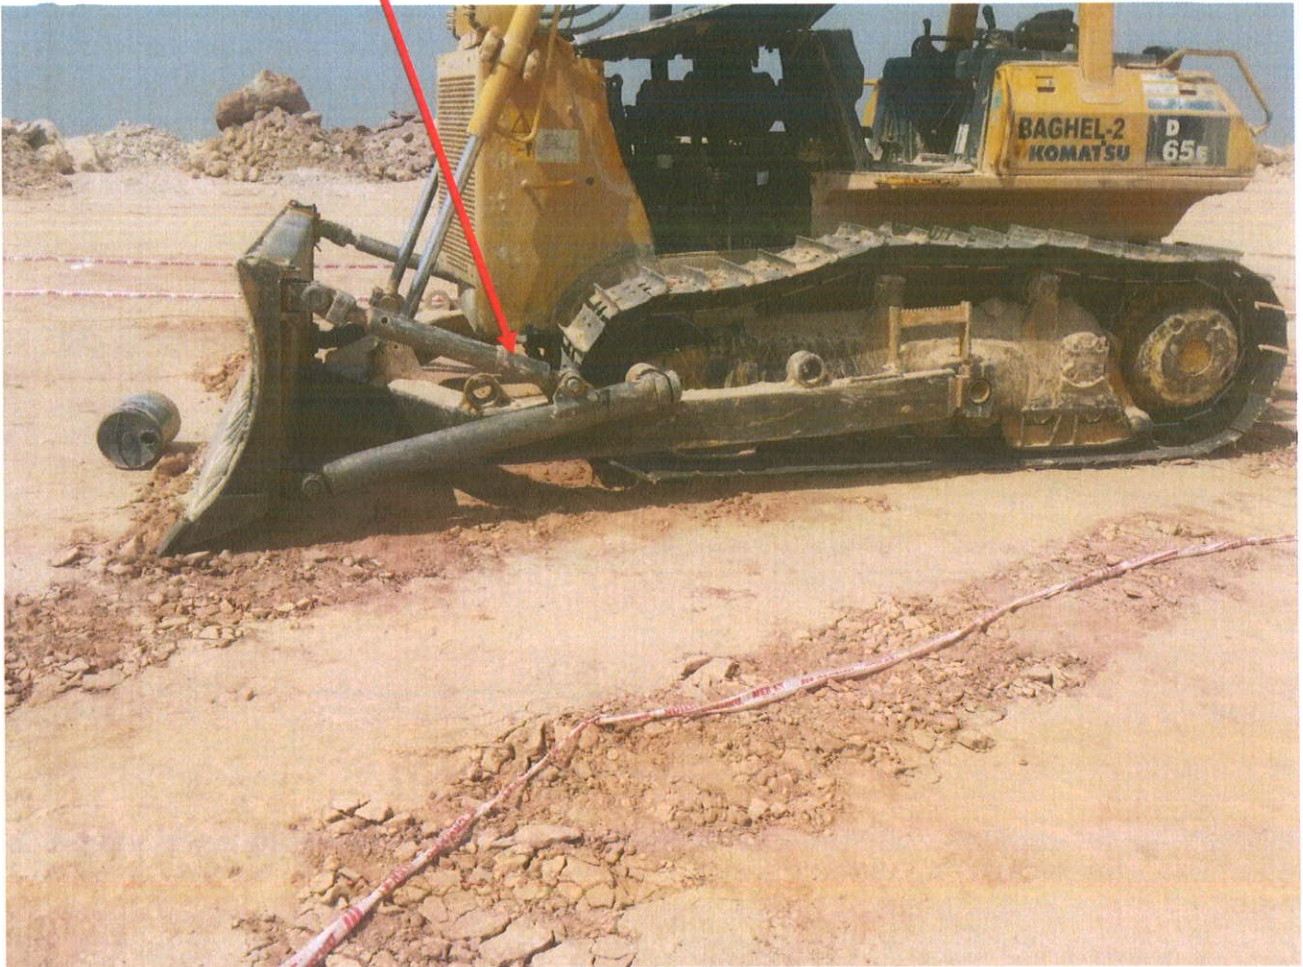
Photo 7 Position of deceased immediately prior to incident. Deceased was lying under the machine draining oil from sump and passing to fellow employee sitting on left track . Position of deceased lying under machine prior to incident

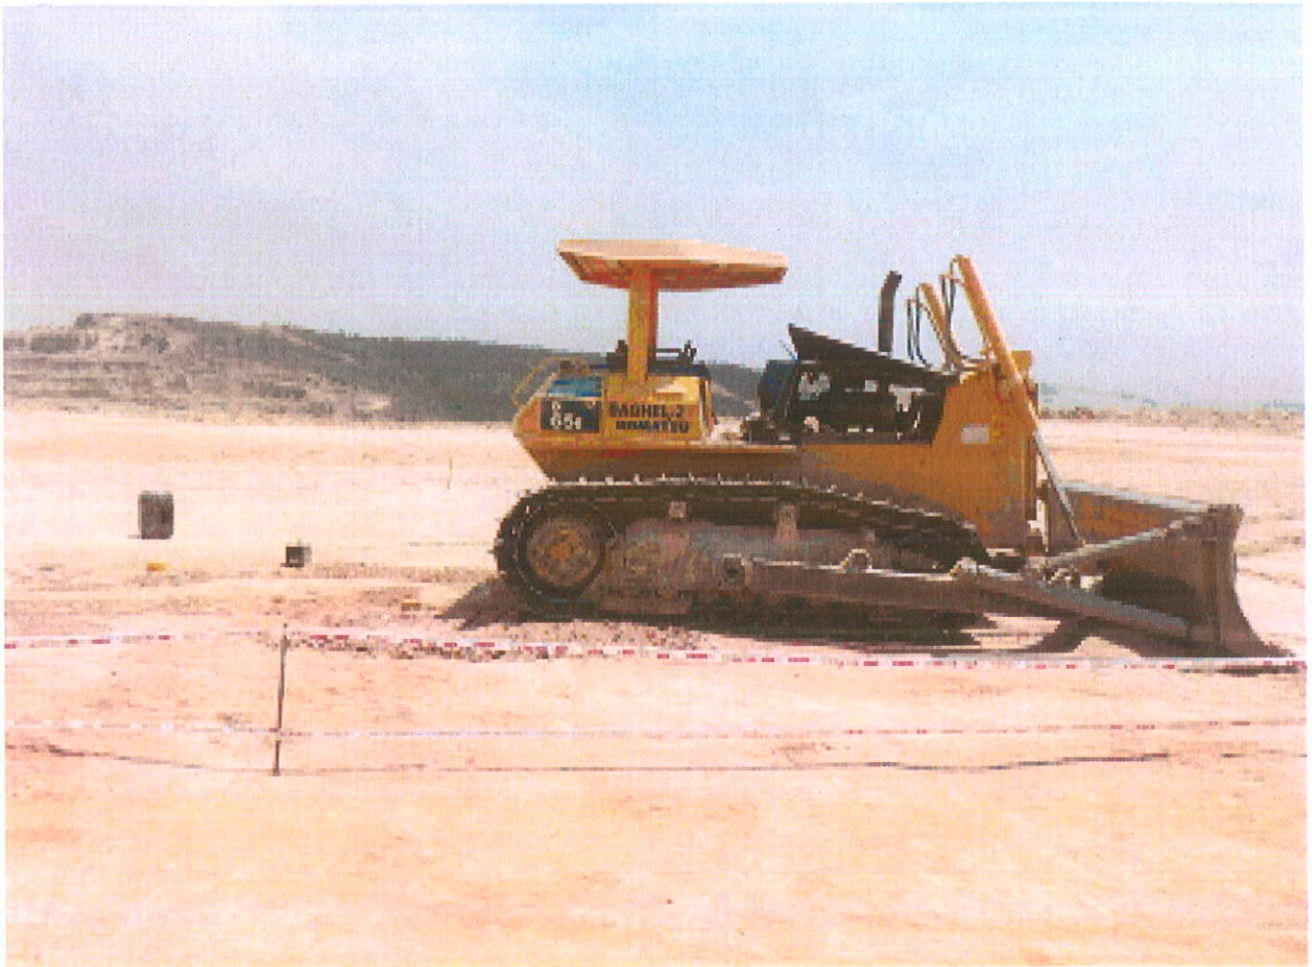
Photo 8; Showing location of Dozer on waste Dump

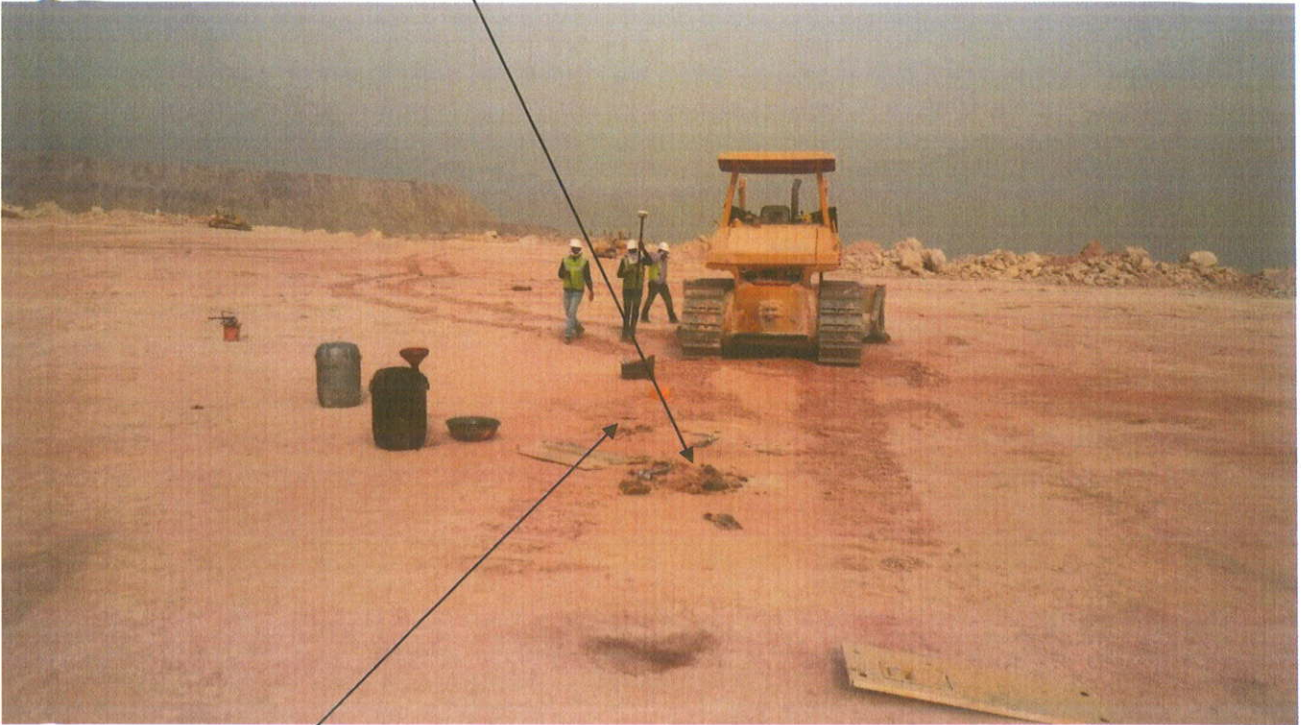
Photo 9. Showing position of the tools.

Position of deceased
