SUBJECT: Technical Assistance Report
The Pasion River Fish Kill Investigation
SESD Project # 15-0383

Technical Assistance Report
The Pasion River Fish Kill Investigation
Sayaxche, El Peten, Guatemala
Inspection Date: July 6-9, 2015
SESD Project ID No. 15-0383

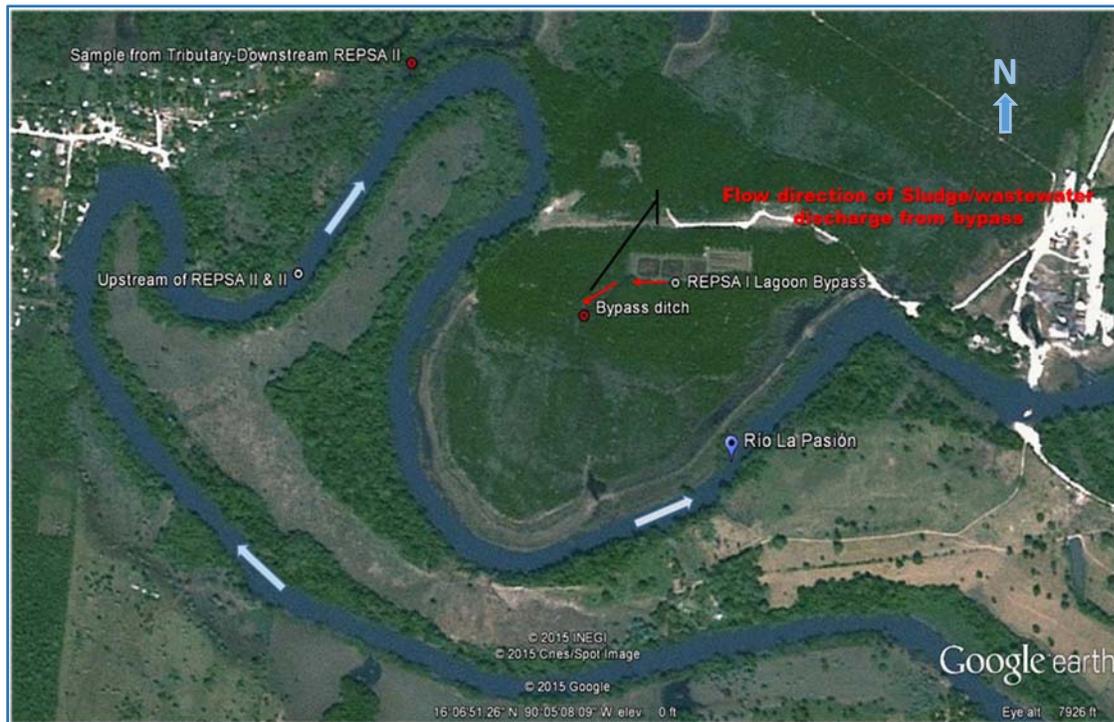
Figure 1: REPSA I Oxidation Lagoon Bypass Location

EPA observed that the wastewater/sludge discharged from the bypass pipe was dark gray in color and had an oily like appearance. Refer to Photos 2 through 5, pages 17-19, for details. **Figure 1** shows the location of the anaerobic lagoon bypass and the direction of the wastewater/sludge discharge.

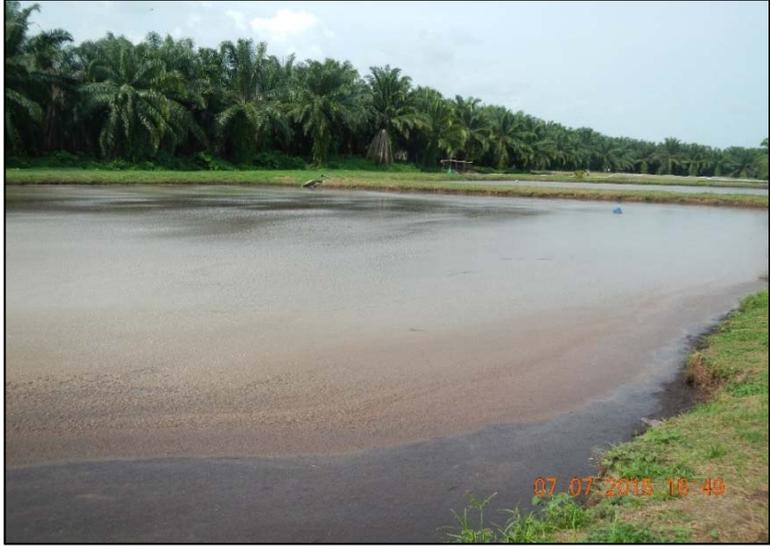
Photo taken by: John Ruiz		Project Name: The Pasion River Fish Kill Investigation Technical Assistance	
Photo No: 1	Date: 07/07/2015

During the EPA visit, it was observed that the REPSA I lagoons were almost full to capacity, with a free board of approximately one foot (0.3 meters) (See photo 1, page 17). Typically, lagoons should have a minimum freeboard of 0.9 meters (3 feet) (USEPA, 2002). The minimum freeboard design criteria is recommended in an effort to avoid or minimize overflow during rain events of significant magnitude. In addition, EPA and MARN detected a very strong hydrogen sulfide odor similar to rotten eggs originating from the lagoon treatment system. At the time of the inspection, REPSA I was discharging untreated anaerobic sludge through a 15-cm (6-in) bypass pipe from the bottom of the anaerobic lagoon into an open channel area (See photo 2, Page 17). This bypass practice may short-circuit the hydraulic flow of the treatment process and

Direction Photo Taken: East			
Description: View of REPSA I's anaerobic lagoon where the bypass was observed. Lagoon was in full to capacity with a freeboard of approximately one foot.

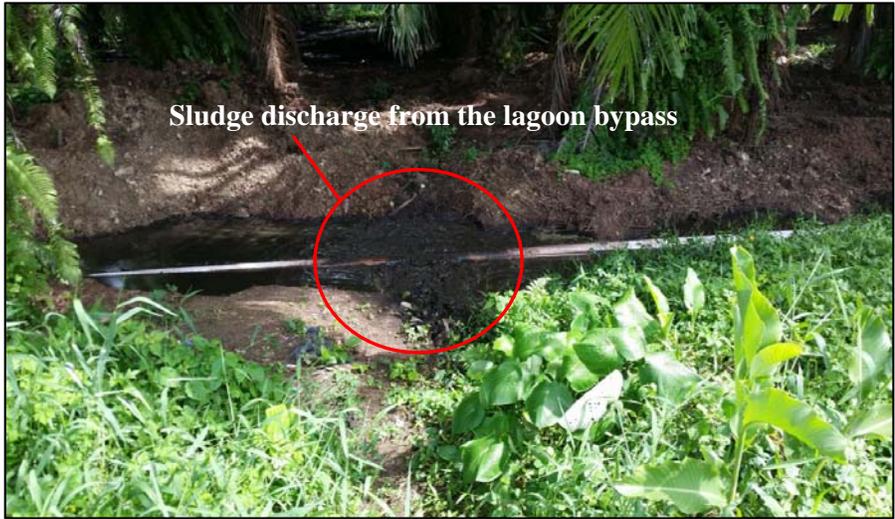
Photo taken by: Jairo Castillo		Project Name: The Pasion River Fish Kill Investigation Technical Assistance	
Photo No: 2	Date: 07/07/2015

consequently adversely impact the overall treatment of the wastewater. Typically in this type of system, higher concentrations of contaminants are found in the bottom of the lagoon. Consequently, the bypass was discharging potentially the highest concentrations of contaminants outside of the wastewater reuse system. According to MARN's inspectors, REPSA also had not submitted to MARN its Environmental Assessment Instrument to evaluate the environmental impacts of its operations in the area, including an evaluation of the criteria used for the design of the oxidation lagoons. Since REPSA only had authorization to reuse the treated wastewater in the authorized irrigation fields, then this type of practice violated the Government Agreement 236-2006, Articles 34 (Wastewater Reuse Parameters), 55 (Disposal Prohibition of Wastewater), and 56 (Direct Discharge Prohibition), and therefore, can be considered an illegal discharge.

Direction Photo Taken: South			
Description: View of the bypass discharging anaerobic sludge into a ditch. The bypass was discharging sludge when EPA-MARN arrived at the plant.

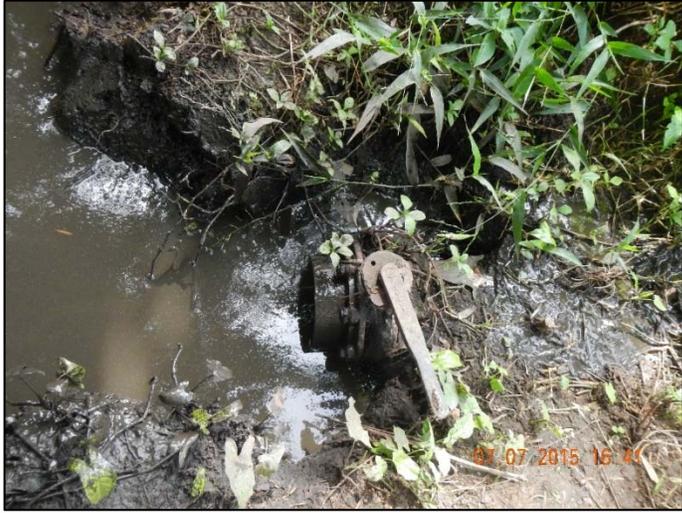
Photo taken by: John Ruiz		Project Name: The Pasion River Fish Kill Investigation Technical Assistance	
Photo No: 3	Date: 07/07/2015

Direction Photo Taken: West			
Description: View of the six-inch bypass with the valve closed.

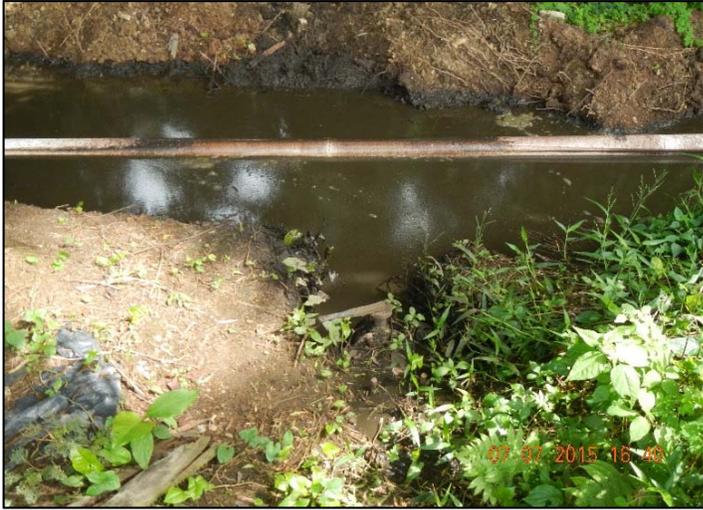
Photo taken by: John Ruiz		Project Name: The Pasion River Fish Kill Investigation Technical Assistance	
Photo No: 4	Date: 07/07/2015

Direction Photo Taken: South			
Description: View of the stagnant sludge on the ditch after REPSA personnel closed the valve.

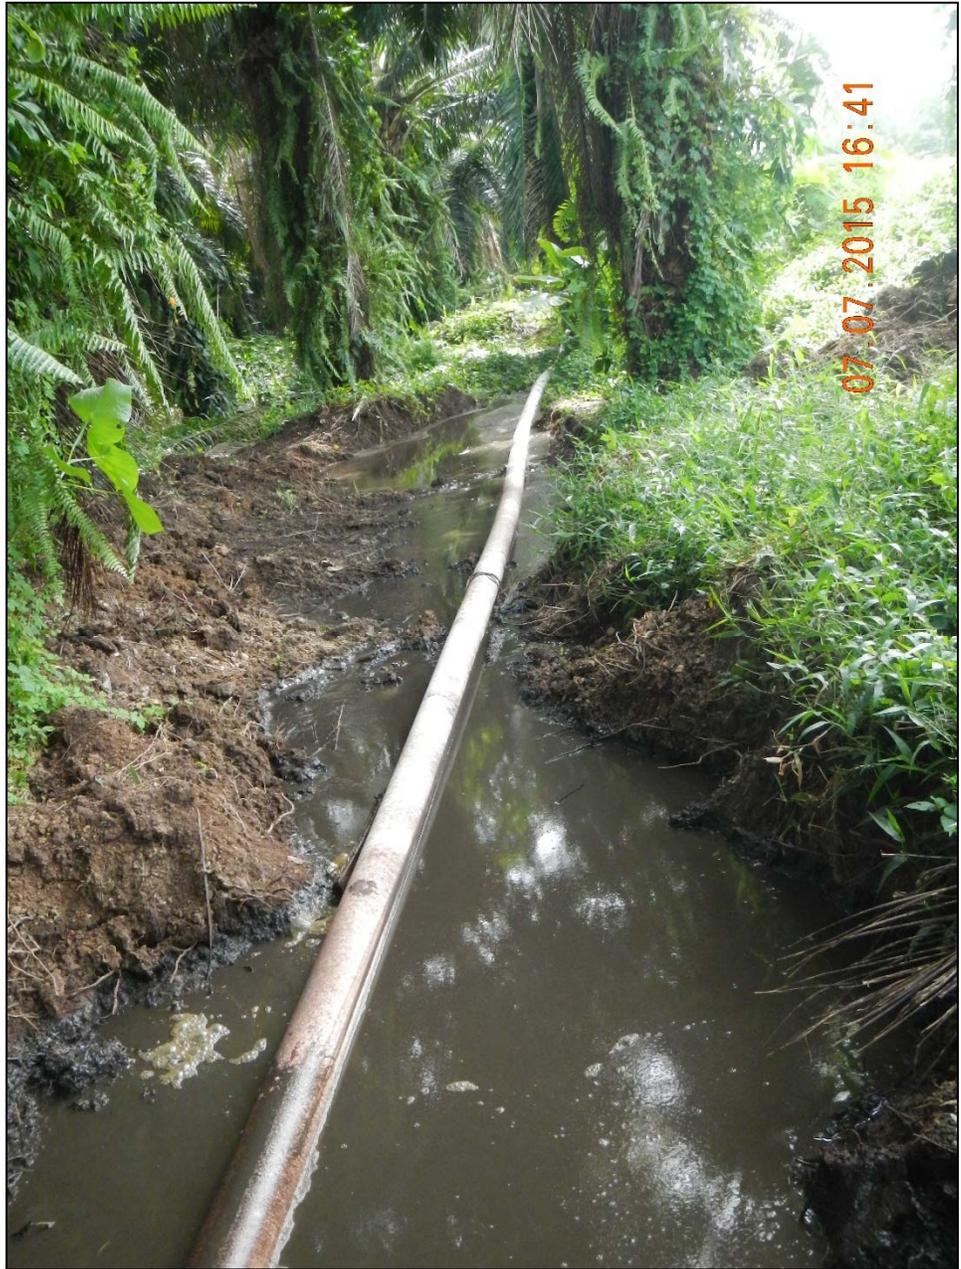
Photo No: 5
Date: 07/07/2015

Description:
View of the drainage channel of the bypass flowing toward the southwest. The Pasion River is located approximately 400 meters toward the south of the lagoon bypass location. Runoff flows downstream towards the river.

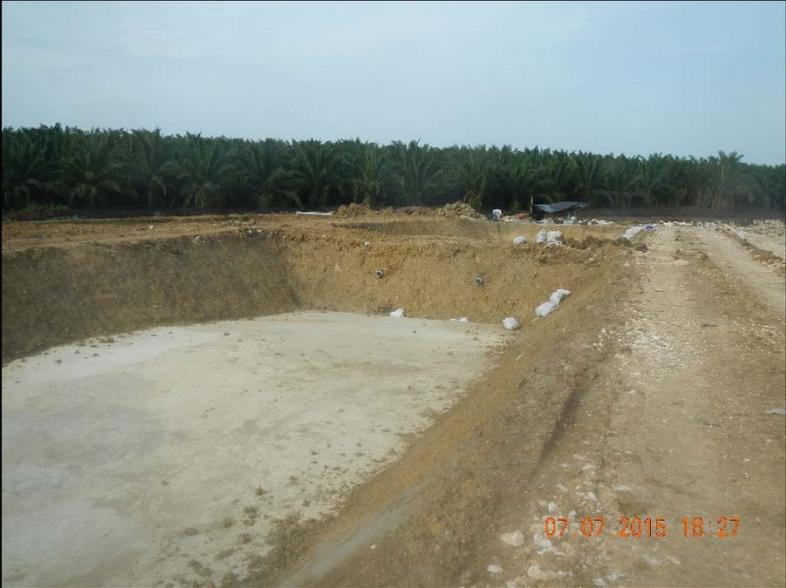
Photo taken by: John Ruiz		Project Name: The Pasion River Fish Kill Investigation Technical Assistance	
Photo No: 6	Date: 07/07/2015

EPA and MARN also performed a walk-through to the REPSA II oxidation lagoon system. REPSA was expanding the lagoon system from nine lagoons to twelve new lagoons, for a total of twenty-one lagoons (See photos 6 through 8, pages 20-21). The system is composed of cooling lagoons, anaerobic and settling lagoons. The treatment system also included a 1,200 m³ digester lagoon for anaerobic sludge treatment. New lagoons were constructed with a concrete foundation. Eng. Edgar Moran stated that the construction of the new lagoons started on May 2015 (approximately two months before the EPA-MARN inspection). At the time of the inspection, REPSA II was put out of line because of the fish kill investigation conducted by MARN. The facility transferred part of the REPSA I wastewater generated from the palm oil manufacturing process to the REPSA II oxidation lagoon system. REPSA as a whole is planning to expand the production of palm trees from 150 hectares to 300 hectares in the coming years.

Direction Photo Taken: North			
Description: View of REPSA II expansion of the oxidation lagoons treatment system. A concrete slab was observed at the bottom of each new lagoon.

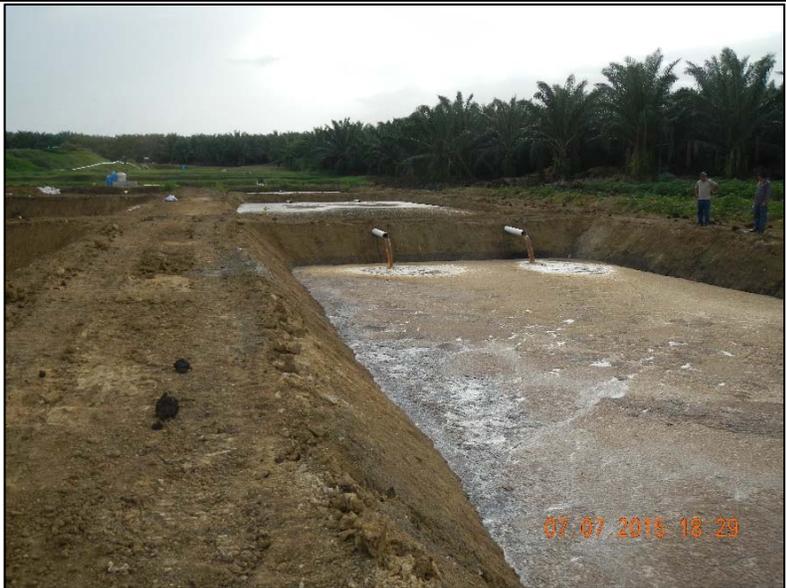
Photo taken by: John Ruiz		Project Name: The Pasion River Fish Kill Investigation Technical Assistance	
Photo No: 7	Date: 07/07/2015

Direction Photo Taken: North			
Description: View of new anaerobic lagoon. REPSA I was transferring part of the wastewater to the REPSA II new plant.

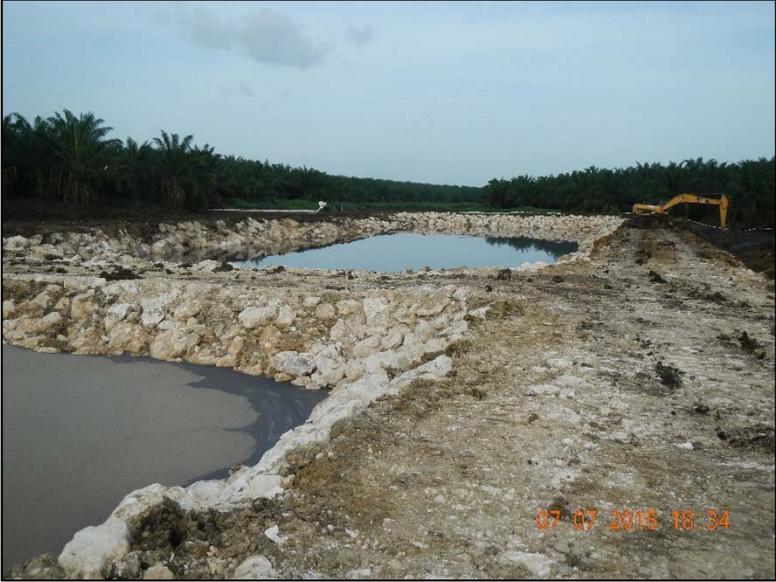
Photo taken by: John Ruiz		Project Name: The Pasion River Fish Kill Investigation Technical Assistance	
Photo No: 8	Date: 07/07/2015

Direction Photo Taken: South			
Description: View of REPSA II's sludge digester lagoon (left) and final settling lagoon.

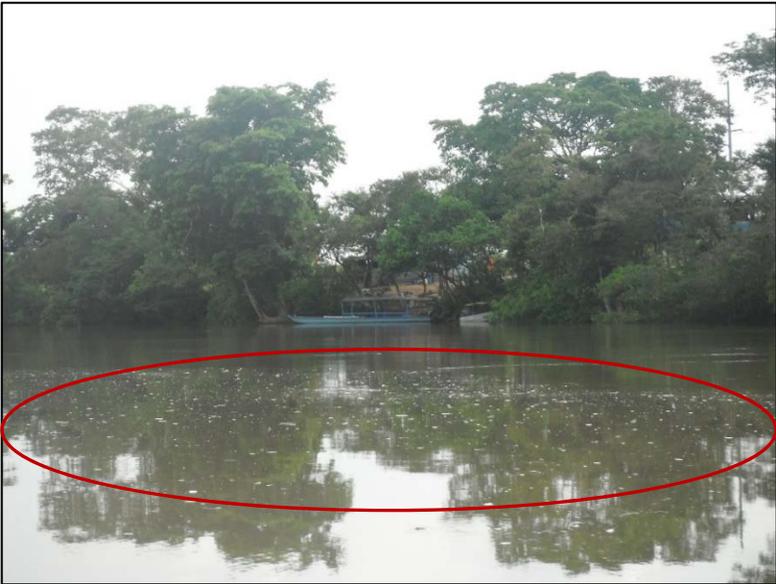
Photo taken by: Jairo Castillo		Project Name: The Pasion River Fish Kill Investigation Technical Assistance	
Photo No: 9	Date: 07/08/2015

On July 8, 2015, EPA and MARN conducted a site reconnaissance on the Pasion River, near the cities of Sayaxche, El Ceibal, and Cedral. The river water appeared turbid. In addition, a large oil like sheen with debris was observed at the river water surface (See photo 9, page 21). EPA and MARN personnel observed sewage seeping from the ground and flowing directly into the Pasion River at the City of Sayaxche ferry area. (See photo 10, page 22). EPA also observed Sayaxche residents collecting water near the sanitary leaking area that reportedly will be used for some sort of human consumption (See photo 11, page 22).

Direction Photo Taken: North			
Description: View of debris accumulated in an oil sheen observed on the Pasion River. Surface water was observed turbid.

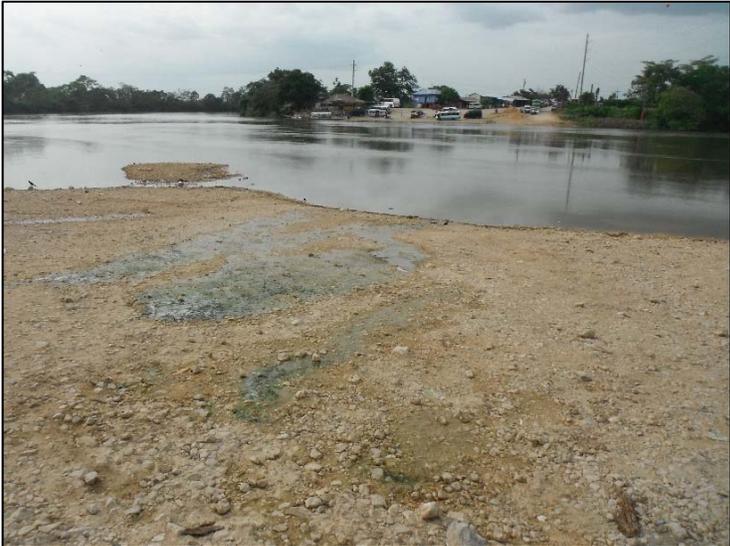
Photo taken by: Jairo Castillo		Project Name: The Pasion River Fish Kill Investigation Technical Assistance	
Photo No: 10	Date: 07/08/2015

Direction Photo Taken: North			
Description: View of the sewage pipes seeping from the ground and flowing directly into the Pasion River. This was observed at the Sayaxche ferry area.

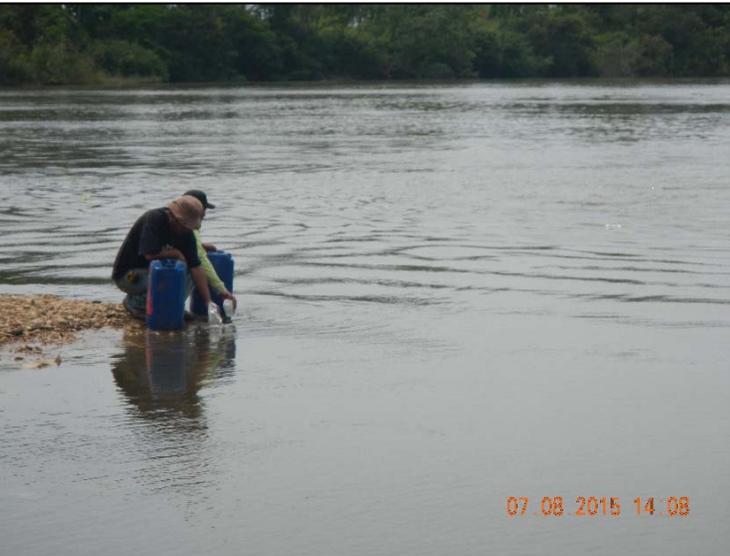
Photo taken by: John Ruiz		Project Name: The Pasion River Fish Kill Investigation Technical Assistance	
Photo No: 11	Date: 07/08/2015

07.08.2015 14.08	
Direction Photo Taken: West			
Description: View of collection of water for human consumption near the sewage pipes location.
