EXECUTIVE SUMMARY

The purpose of the extent of condition review is to evaluate the extent of tube wear in all 4 SGs (2E088, 2E089, 3E088 and 3E089).

Root Cause Evaluation: Unit 3 Steam Generator Tube Leak and Tube-to-Tube Wear
Condition Report: 201836127, Revision 0, 5/7/2012
San Onofre Nuclear Generating Station (SONGS)

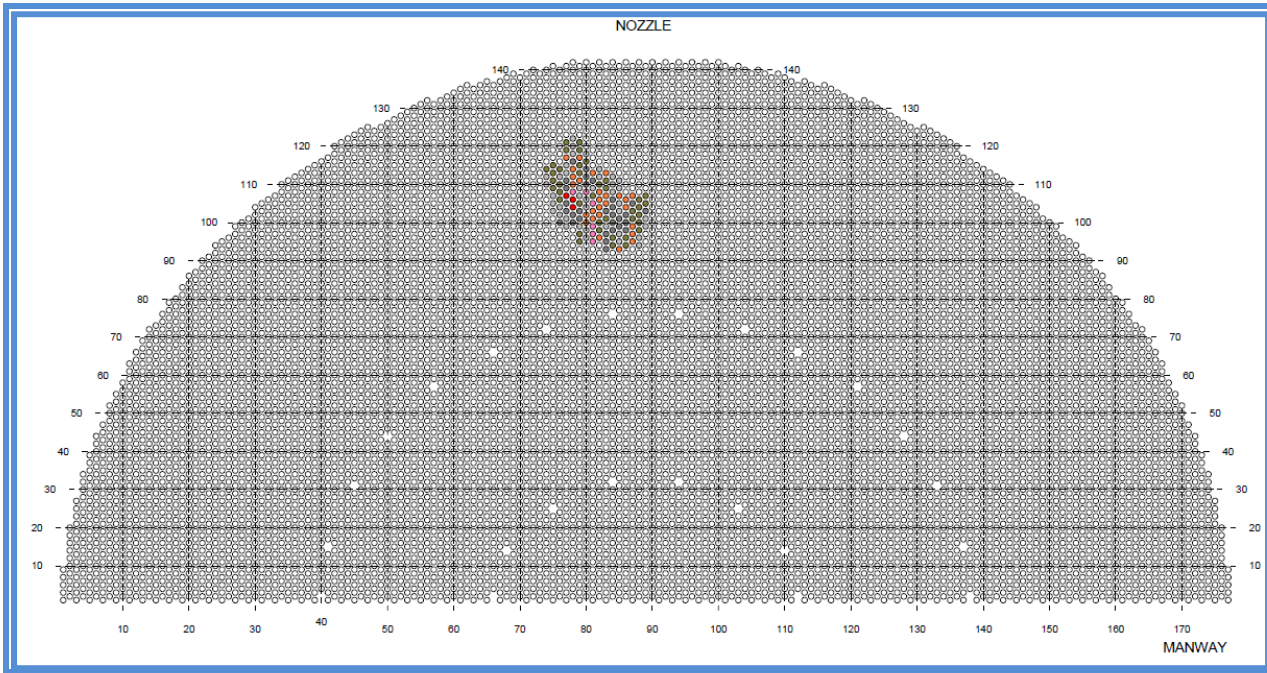
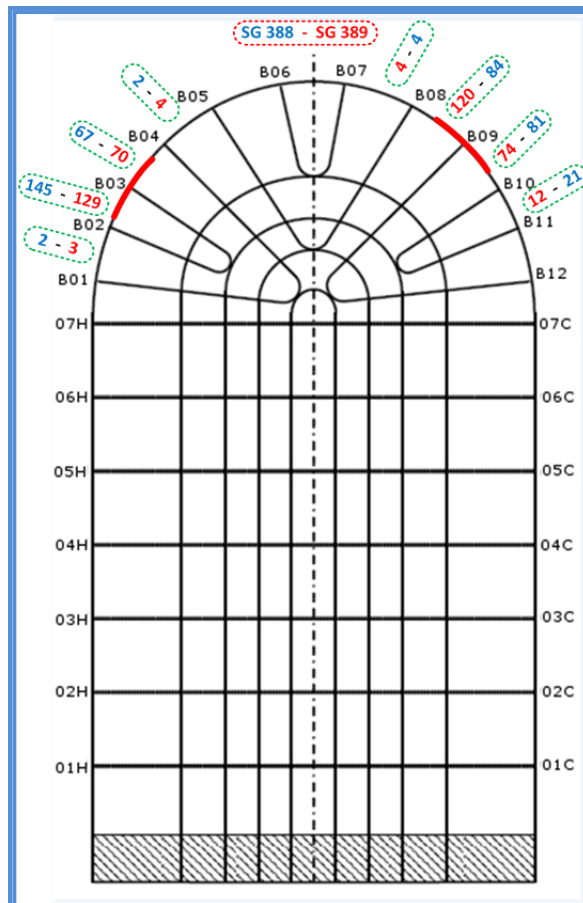
Attachment 04: SG Tube Wear Indications (FIGURES)

See Attachment 04 for a partial set of diagrams depicting tube wear locations in Unit 3.

The primary to secondary tube leak in 3E088 was due to through wall tube-to-tube wear. ECT inspection of the tubes in 3E088 and 3E089 identified a total of 326 tubes with tube-to-tube wear. In-situ pressure testing was performed on 73 tubes in 3E088 and 56 tubes in 3E089 due to higher levels of tube-to-tube wear (the wear indications in these tubes exceeded the condition monitoring limits of the SG Program). This testing resulted in eight tubes in 3E088 that did not meet leakage and/or structural performance criteria as required by Technical Specifications. All other tubes in-situ tested met the performance criteria.

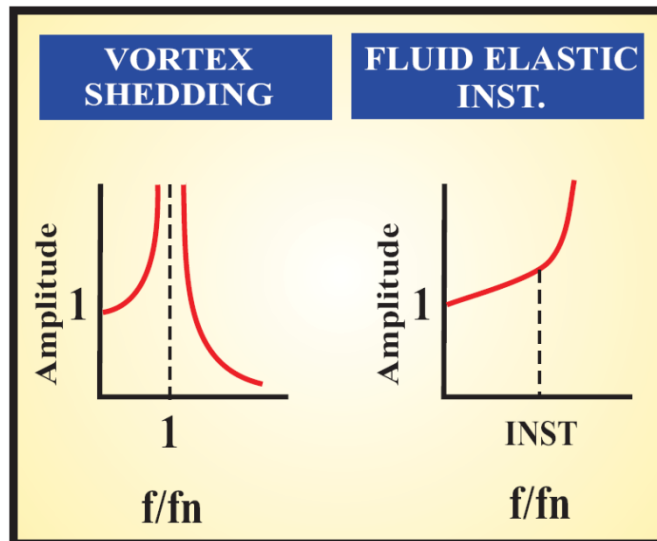
other Flow-Induced-Vibration mechanisms such as vortex shedding, FEI grows exponentially once the critical velocity is reached as shown in the graph below (Ref. 53);

This exponential growth can create high amplitudes of vibrations causing substantial wear and damage to steam generator tubes and associated equipment, similar to what has been seen at SONGSs. Small changes in one variable from the FEI equation can have considerable impact on a system, and its stability against FEI. Three of the primary variables being evaluated are; natural frequency of tubes, and how it changes with loss of active supports, the damping coefficient assumed for FIV modeling, and tube cross flow velocities.

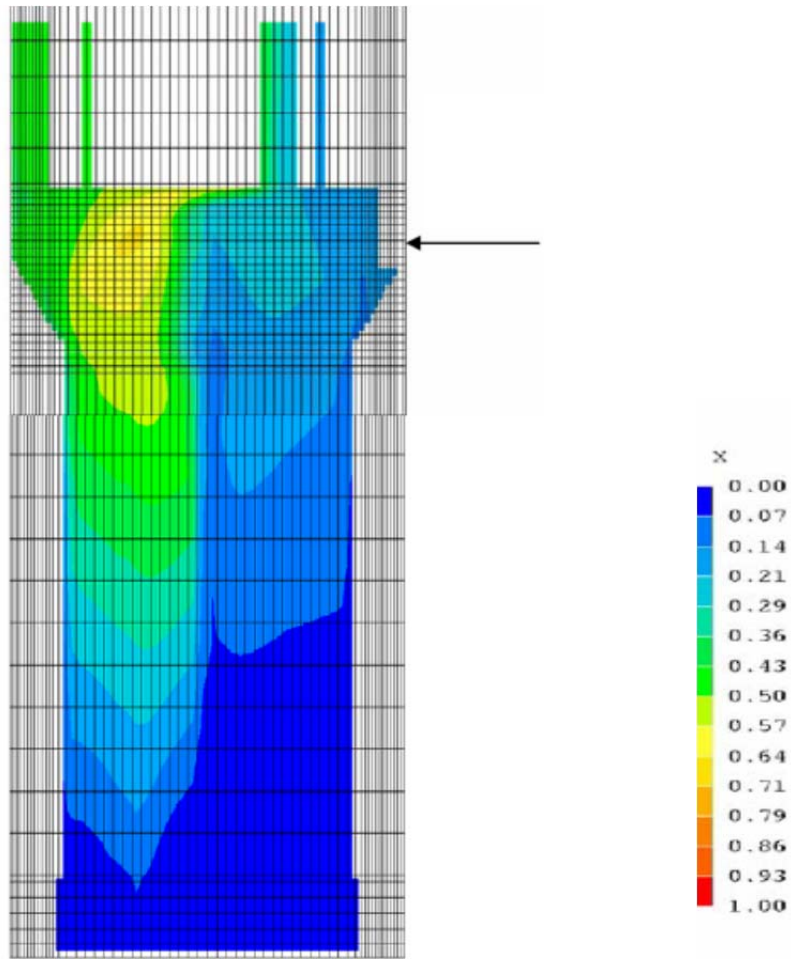
Figure 1: Contour of steam quality in the vertical cross-section for $T_{\text{hot}} = 598^{\circ}\text{F}$
(Figure 8.1-1 (a) in Reference [2])

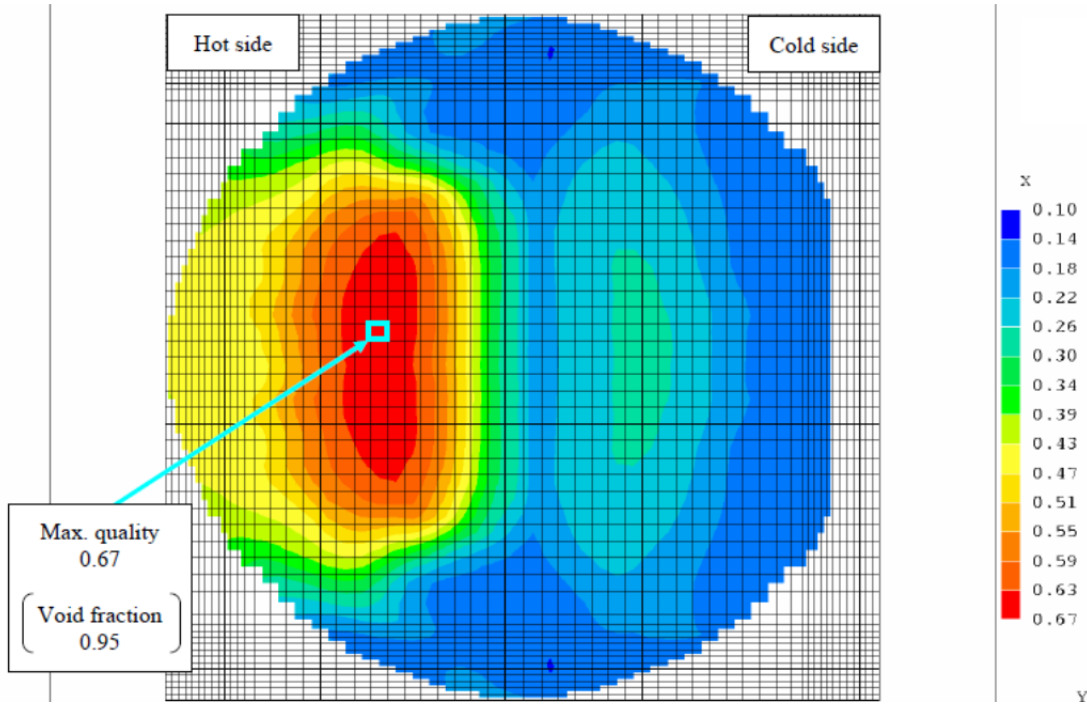
Figure 2: Contour of steam quality at the height of the maximum quality in U-bend region for $T_{hot} = 598^{\circ}\text{F}$
