# SAN ONOFRE'S STEAM GENERATORS: SIGNIFICANTLY WORSE THAN ALL OTHERS NATIONWIDE

JULY 11, 2012

FAREWINDS ASSOCIATES

REPORT COMMISSIONED BY FRIENDS OF THE EARTH

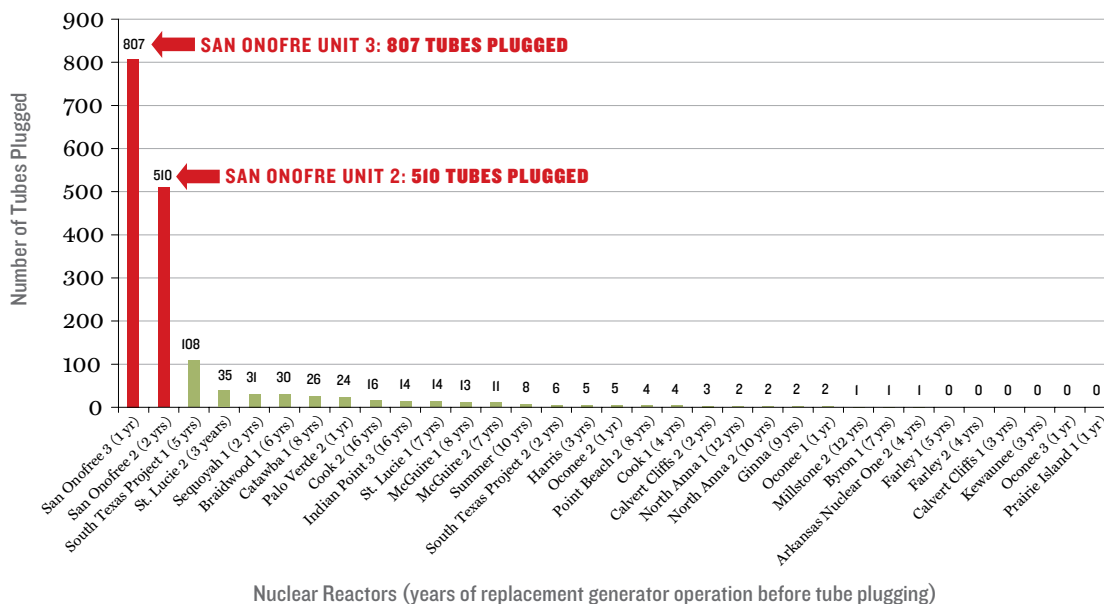
**Figure 1**

As evidenced in Figure 1, Edison has plugged 3.7 times more tubes in its San Onofre Units 2 and 3 replacement steam generators than the nationwide total of all plugs inserted in all the remaining replacement steam generators in all US nuclear reactors. Moreover, the NRC and Edison have not openly informed the public about the magnitude of tube generator plugging at San Onofre compared to the remainder of U-tube damage at other US reactors.

**U.S. Nuclear Reactors Replacement Steam Generators  
Tubes Plugged to Avoid Generator Failure<sup>3</sup>**

Even a casual overview of the data presented in Figure 1 shows an alarming difference at San Onofre in comparison to other operating US nuclear reactors. The minor differences between the replacement steam generators at San Onofre Units 2 and 3 are inconsequential when those steam generators are compared to replacement steam generators at all other US nuclear power plants.
