# The Mystery of the Missing Bolts: New York City's Stricken Indian Point Nuclear Plant

# A collaboration between Friends of the Earth and Fairewinds Associates, Inc May 24, 2016

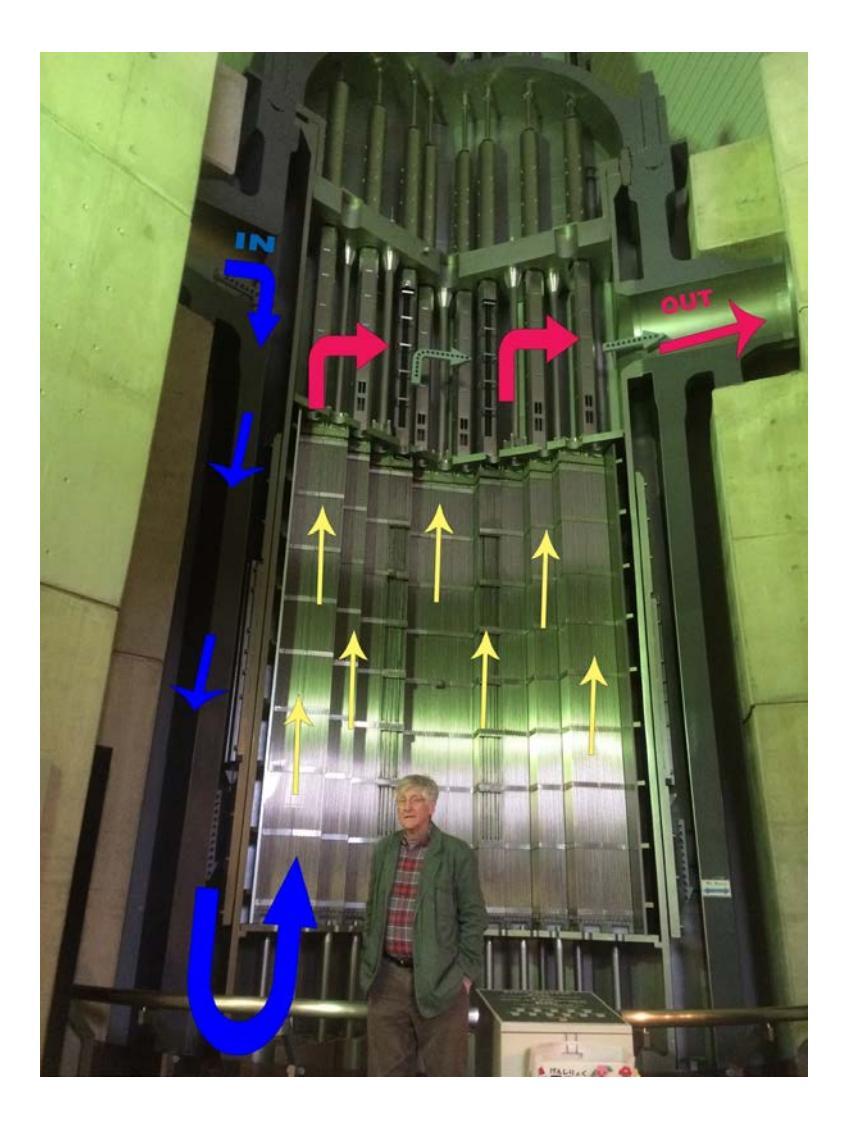
**Figure 1** shows Fairewinds Associates' Chief Engineer at a full-scale mockup of a Westinghouse nuclear reactor similar to Indian Point Unit 2. The reactor's emergency cooling water, depicted in blue, enters at the upper-left corner. When the baffle bolts and other reactor internals are functioning properly, the water descends along the outside of the reactor's "core barrel" to the base of the reactor. It then moves uniformly upward through the nuclear core, keeping the core temperature in the safety zone, before exiting the reactor at top right.

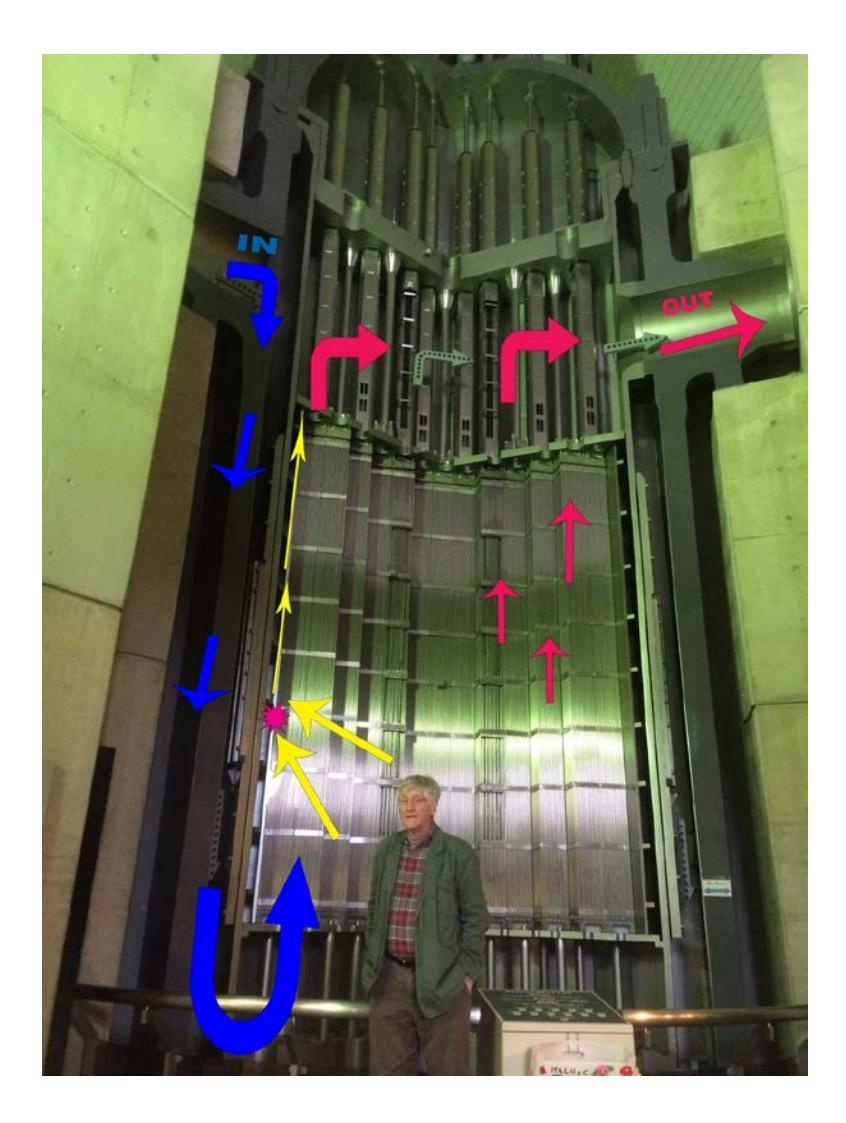
**Figure 2** illustrates how missing or damaged baffle bolts can cause the reactor to overheat. If the bolts fail, the plates will open, allowing the cooling water to deviate from its normally tightly constrained path through the reactor, risking overheating of the reactor core and an uncontrollable nuclear reaction and meltdown.
