FAR OUTSIDE THE NORM:
The San Onofre Nuclear Plant's
Steam Generator Problems
in the
Context of the National Experience with
Replacement Steam Generators

by
Daniel Hirsch
and
Dorah Shuey

September 12, 2012

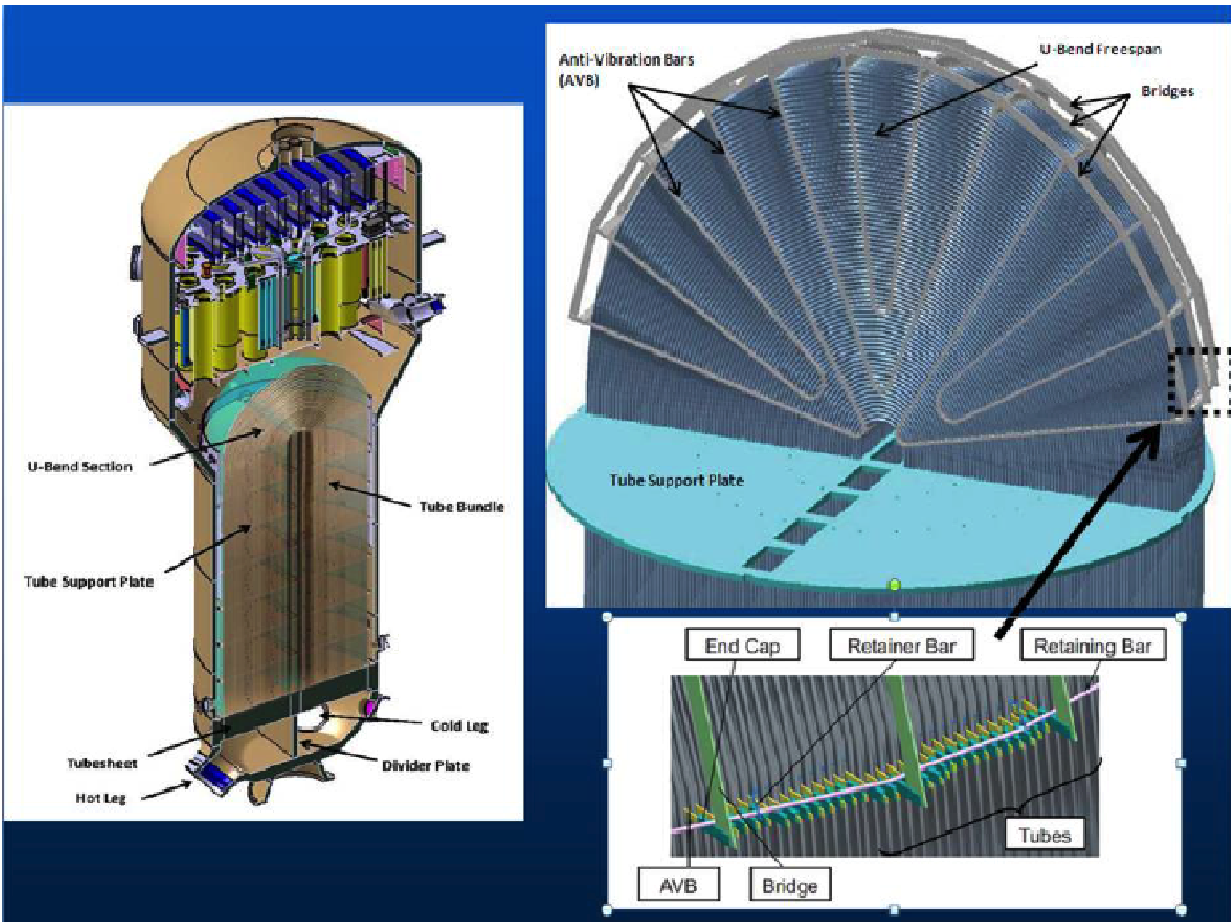
Figure 1 San Onofre Replacement Steam Generator Schematic

The tubes are in an inverted U shape: in the upper part of the steam generator, the tubes bend to return downward again. There are four key parts of the steam generators for the present discussion: the tube support plates, through which the tubes run; the anti-vibration bars (AVBs), designed to reduce vibration; the retainer bars, which help retain the AVBs; and the U-Bend Freespace, where the tubes bend near the top of the steam generator and have no immediate support.

There thus are at least four locations where steam generator tubes can get damaged: they can rub against the tube support plates, the AVBs, the retainer bars, or against each other in the U-Bend Freespace.^{iv} Damage has occurred in the new steam generators at San Onofre at all four locations.
