SUBJECT: Technical Assistance Report
The Pasion River Fish Kill Investigation
SESD Project # 15-0383

Technical Assistance Report
The Pasion River Fish Kill Investigation
Sayaxche, El Peten, Guatemala
Inspection Date: July 6-9, 2015
SESD Project ID No. 15-0383

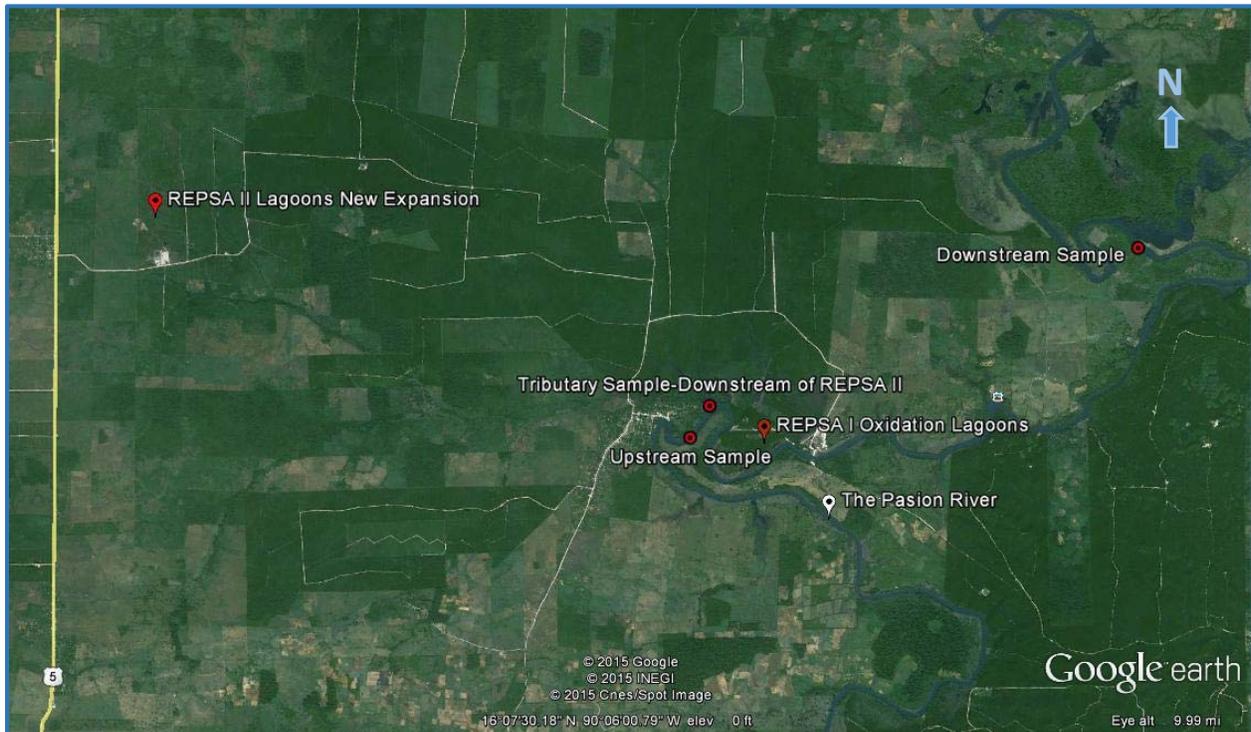
Figure 2: The Pasion River Sample Locations

MARN collected three surface water samples from the Pasion River (See **Figure 2, page 9**). Samples were collected for BOD₅, chemical demand oxygen (COD), TSS, metals, phosphorus, total nitrogen, oils and grease, fecal coliforms, total cyanide, and color analyses. Analytical results were not available at the time of the completion of this report. Upon completion of the analytical results, the results and their interpretation will be provided in an additional report. **Figure 2** describes the sample locations. **Table 2** includes the EPA field measurements collected in the three sampling locations.
